## Bozeman National Guard Armory

**24 W MENDENHALL  
BOZEMAN, MT 59715  
MLS# 181074**

*Property Condition Report*

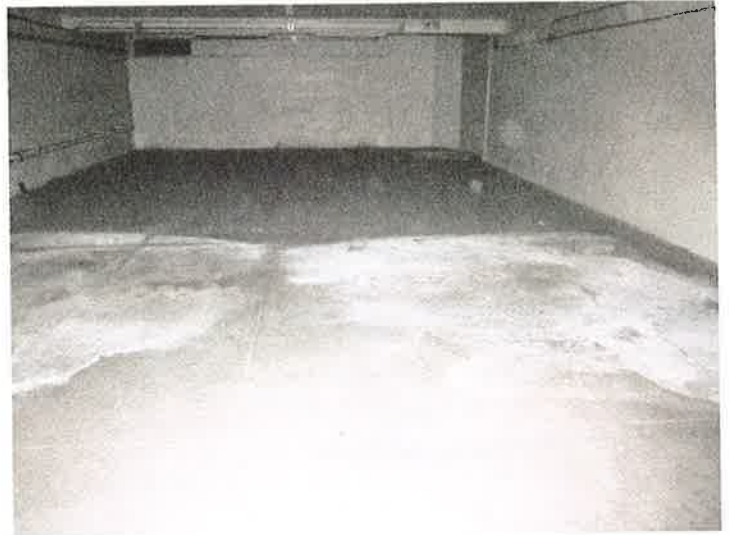
View of floor stain on shooting rang floor in the basement.

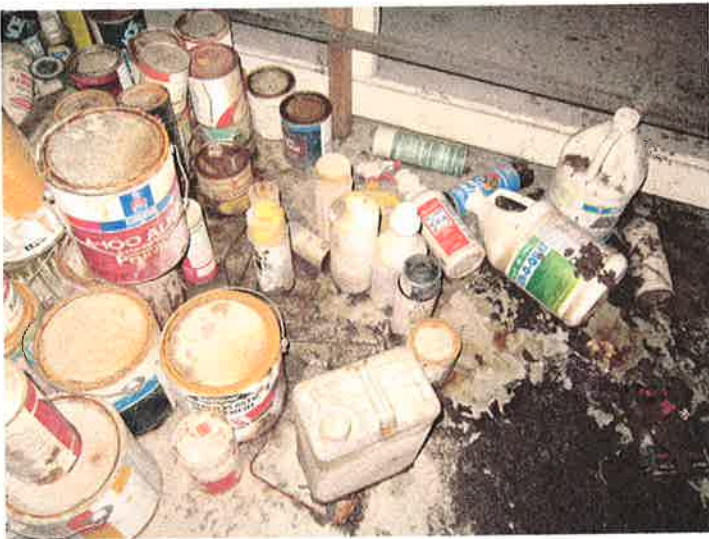
View of leaking chemicals in main floor storage.

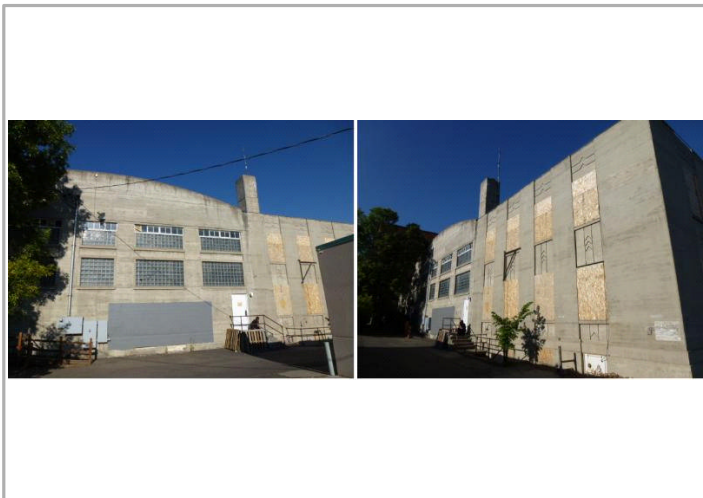
← **Photo #4**

East Elevations.

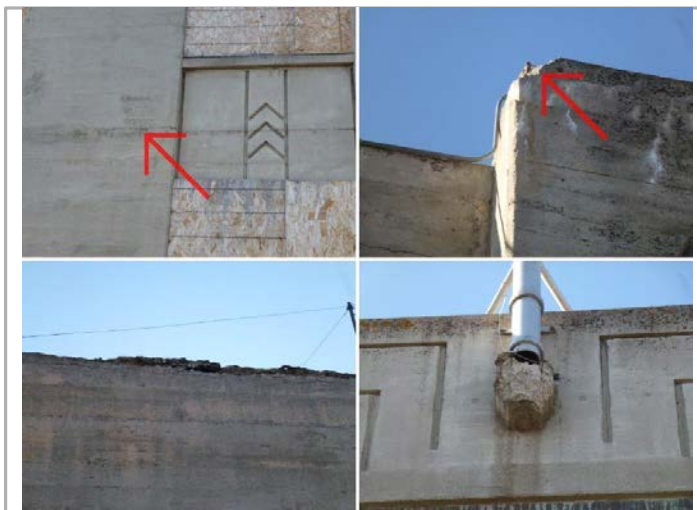
Exterior concrete is cracking and spalling at the north side of the structure at the parapets and at the bottom of the light pole. Recommend further evaluation by a Structural Engineer.

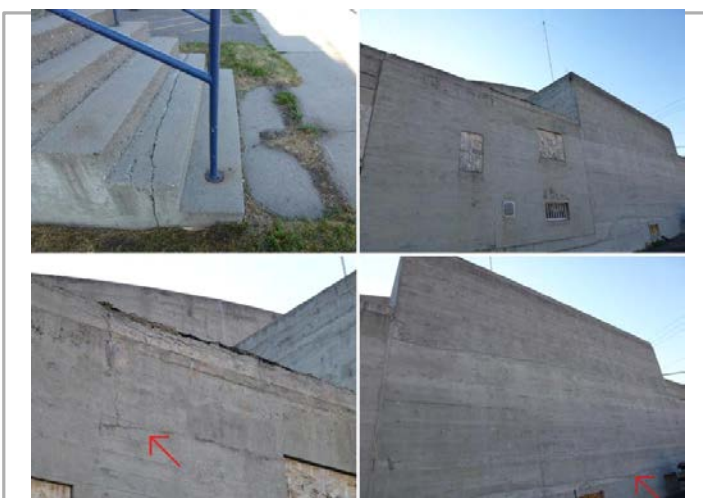
← **Photo #6**

There is a settling crack at the N.W. entry steps. There appears to be horizontal cracking at the west exterior wall. Recommend further evaluation by a Structural Engineer.

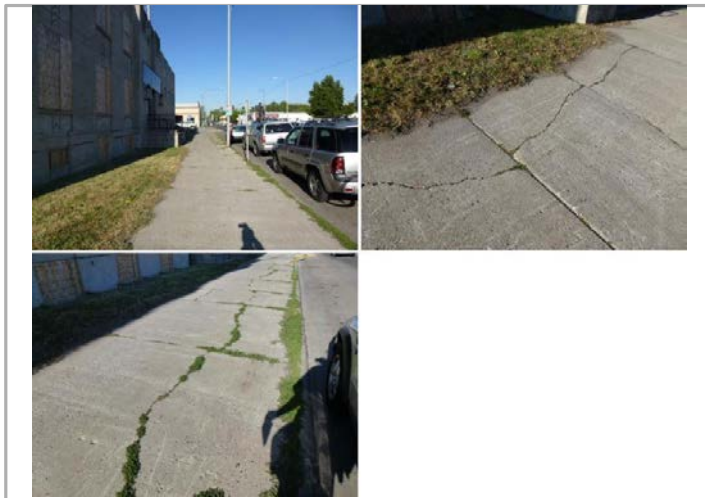
**Photo #7**

The sidewalk at the north side of the property has excessive cracking. Recommend further evaluation by a Flat Work Concrete Contractor.

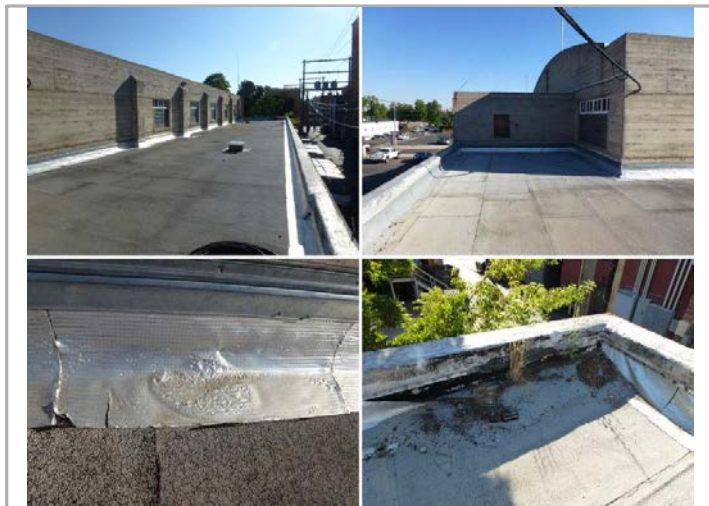
**Photo #9**

Evidence of water ponding was noted at various areas on the flat roof above the south garage. Recommend further evaluation by a Roofer.

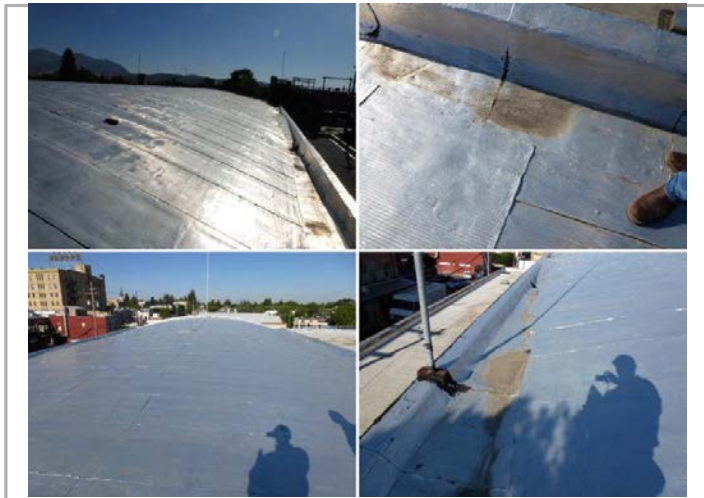
← **Photo #10**

There appears to be inadequate drainage off the barrel roof. Water ponding was noted. Recommend further evaluation by a Roofer. The roof material is delaminating from the roof structure.

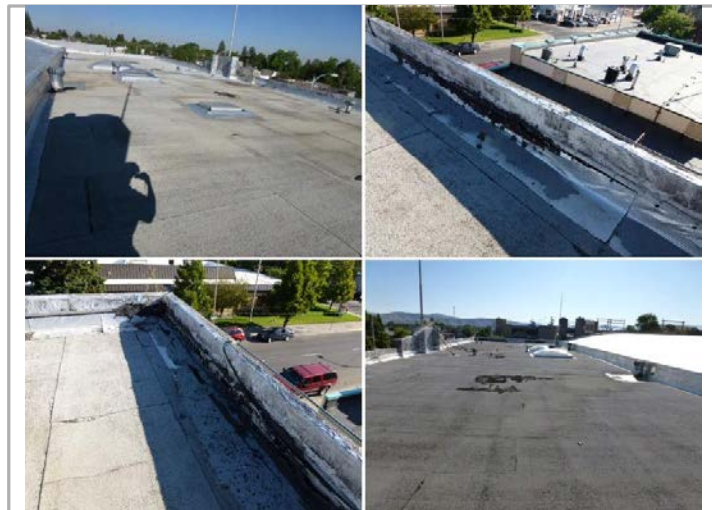
← **Photo #12**

Roof drainage appears to be inadequate at all sides of the roof system. Recommend further evaluation by a Roofer.

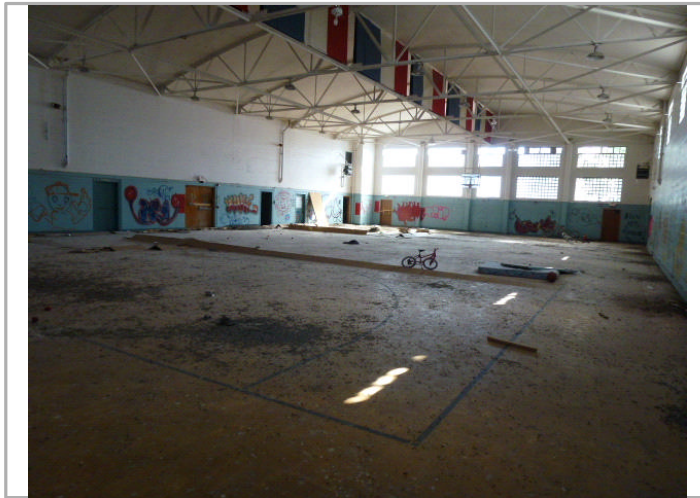
← Photo #13

There are large amounts of pigeon feces in the gymnasium. Pigeon feces may be harmful to the respiratory system, recommend professional remediation. The wood floor in the gymnasium is uplifting due to excessive moisture intrusion.

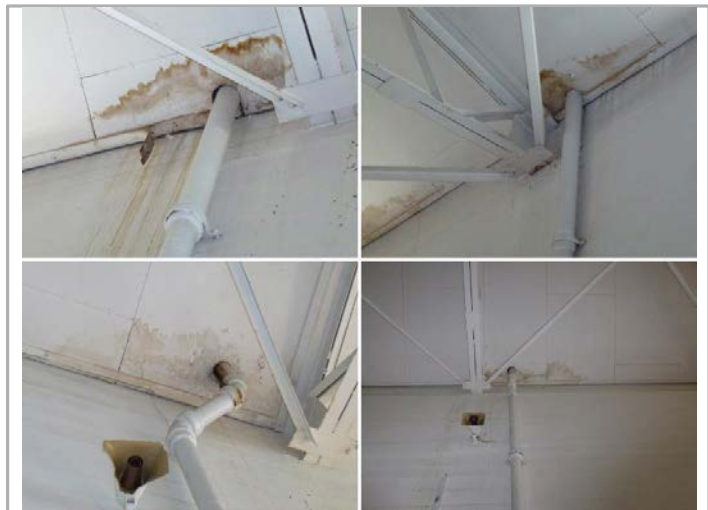
← Photo #15

Water intrusion at the ceiling of the gymnasium noted at the roof drainage pipes on the north and south sides of the room.

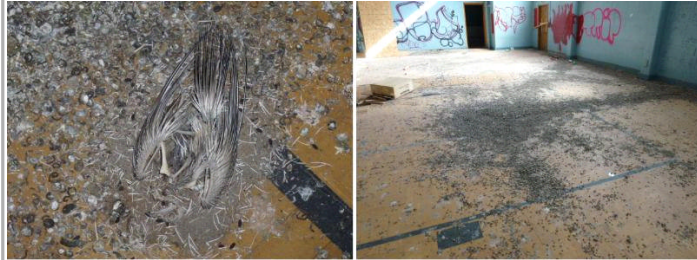
← **Photo #16**

There are numerous areas of bird feces and dead birds through out the structure. Recommend removal for safety reasons.

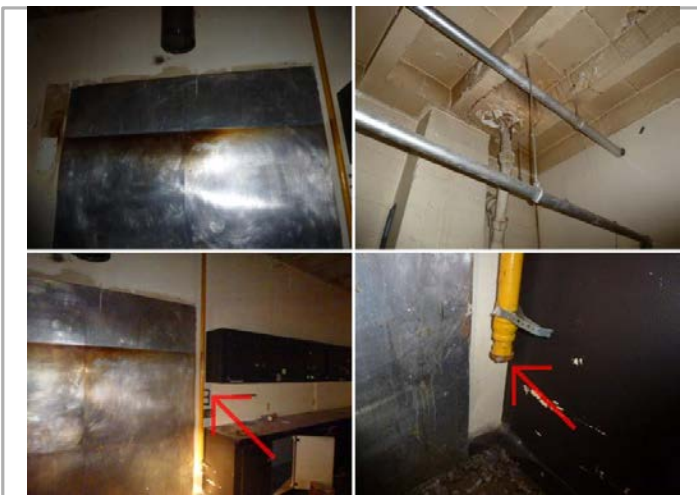
← **Photo #18**

The gas range has been removed from the kitchen. The gas line is still installed with no end cap. Recommend installing a cap on the end of the gas line for safety reasons.

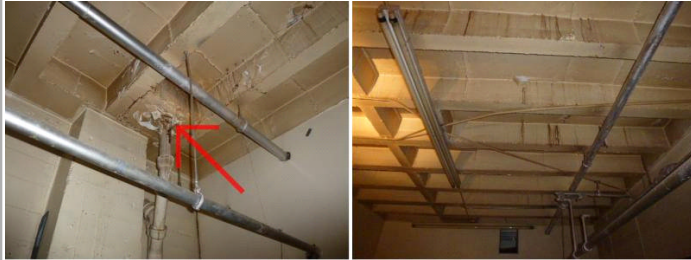
← **Photo #19**

There is moisture intrusion at the ceiling in the kitchen area on the mail level.

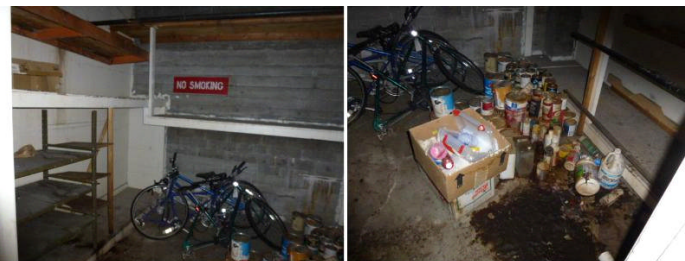
← **Photo #21**

There are paint cans and unlabeled cans in the closet at the west end of the garage, we recommend you have these cans evaluated by a Environmental Engineer prior to any contact.

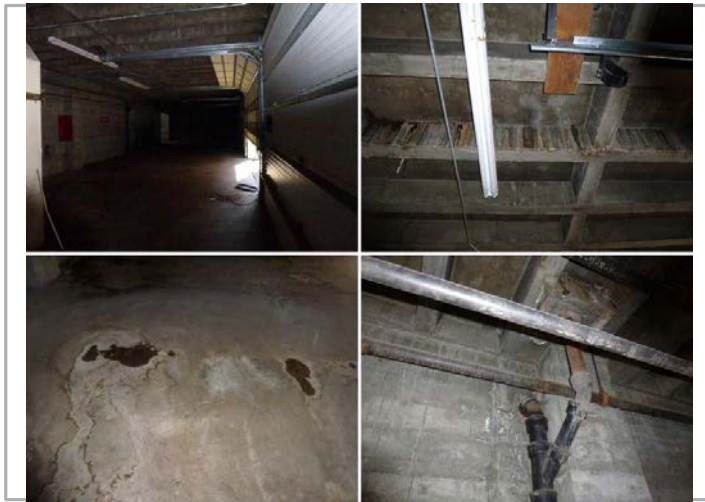
← **Photo #22**

There is notable amounts of water intrusion through the roof in the garage area with standing water on the floor in the garage.

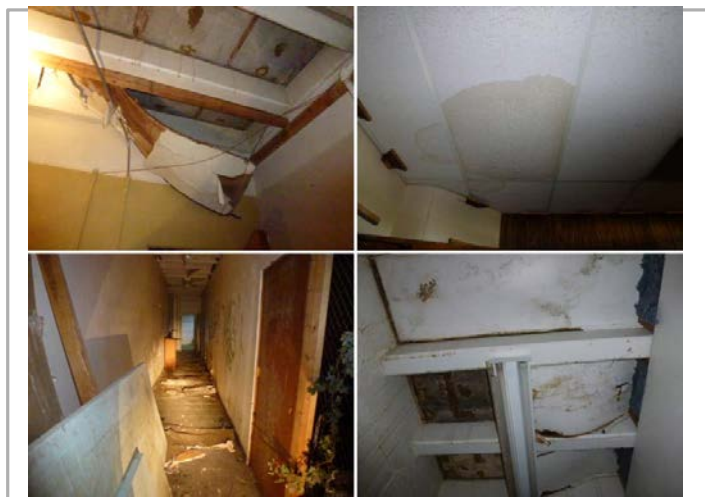
← **Photo #24**

There is extensive moisture damage to the ceiling at the north side of the main floor of the structure.

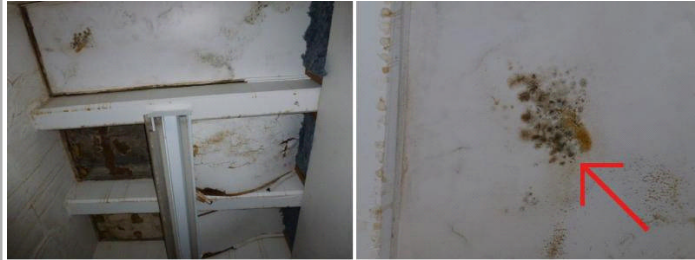
← **Photo #25**

There is black and grey spotted Fungal Growth located in the hallway at the N.W. side of the main floor ceiling.

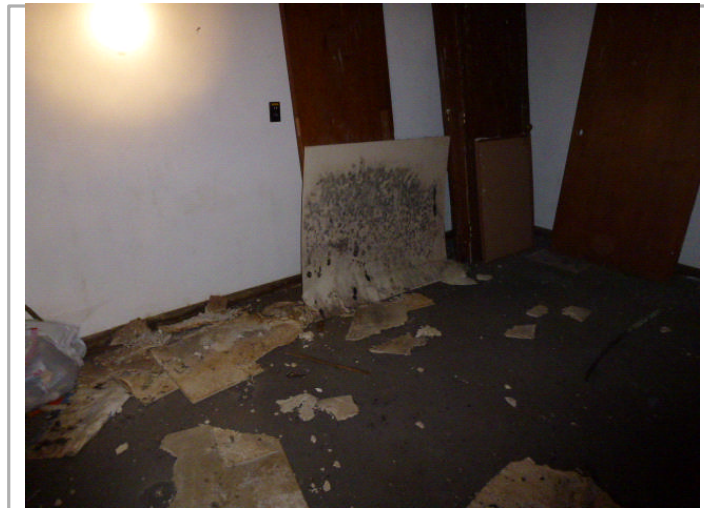
← **Photo #27**

There is a large amount of black spotted Fungal Growth located in the N.W. office on the main floor. Recommend further evaluation.

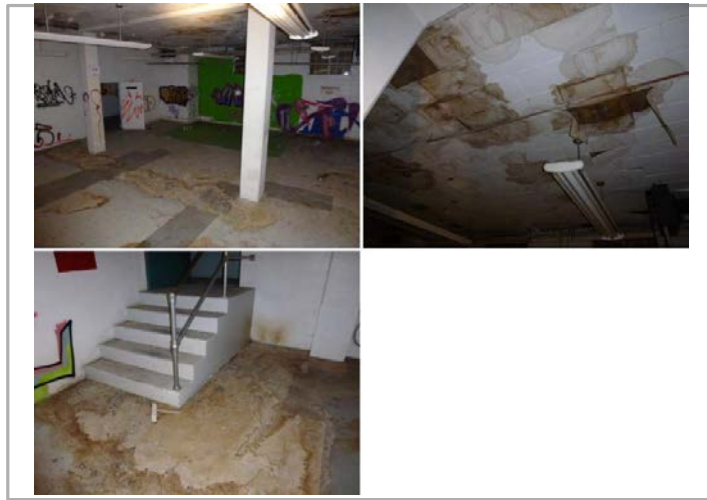
**Photo #28**

There is moisture intrusion and damage at the ceiling located in the basement N.W. corner room.

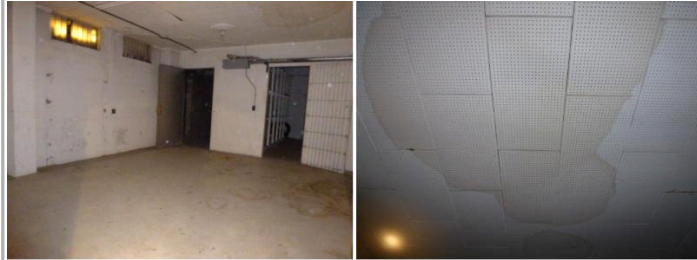
← **Photo #31**

Moisture staining noted at the ceiling at the S.E. weapons room in the basement.

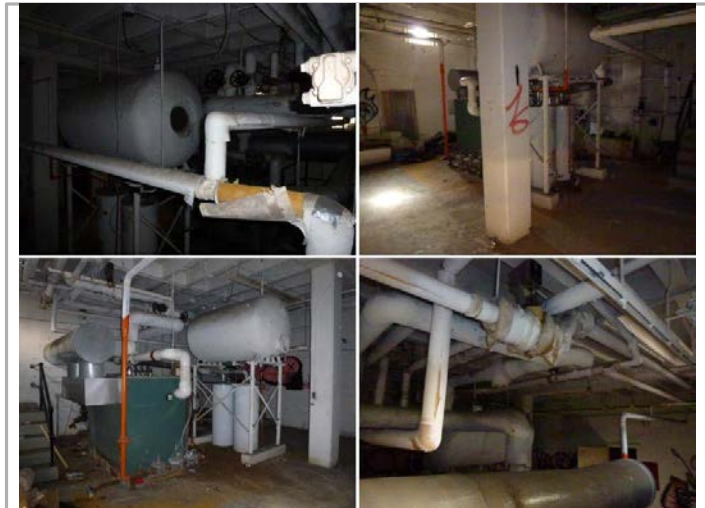
← **Photo #33**

The boiler is located in the mechanical room located at the N.E. corner of the basement. The gas and water was off to this unit on the day of the assessment thus we could not fully evaluate the unit. Recommend further evaluation by Williams Plumbing and Heating.

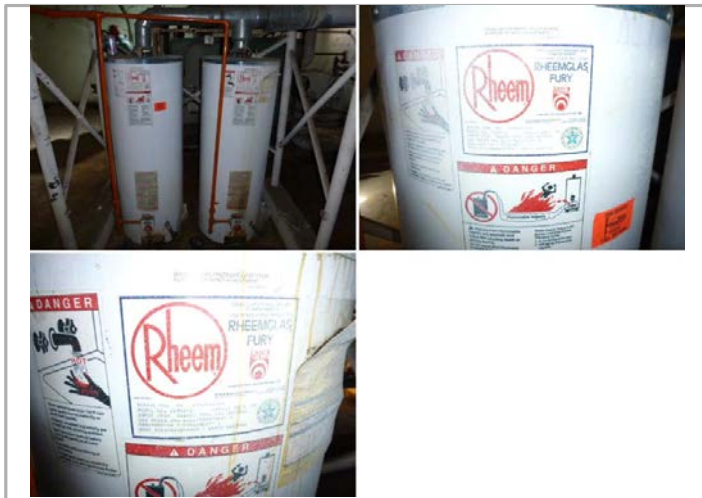
← **Photo #34**

There are two gas fired 1990 Rheem 50 gallon hot water heaters located in the mechanical room. The gas and water is off to these units. Recommend further evaluation by a plumber.

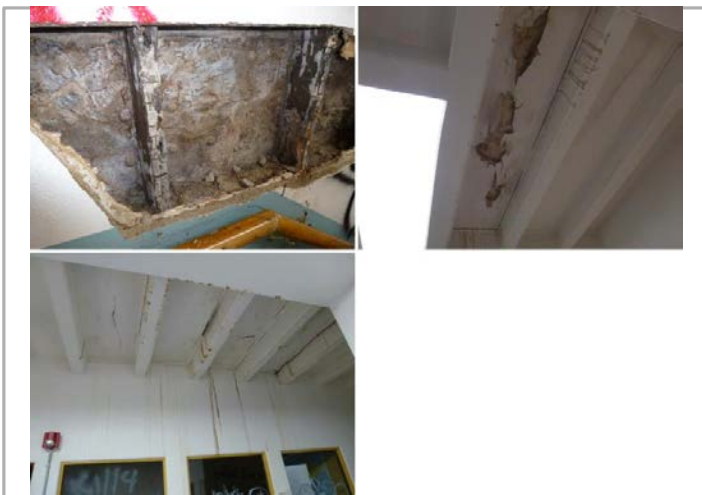
← **Photo #36**

There is a large amount of moisture damage on the ceiling and walls located at the top of the stairs on the upper level. Recommend further evaluation by a Structural Engineer.

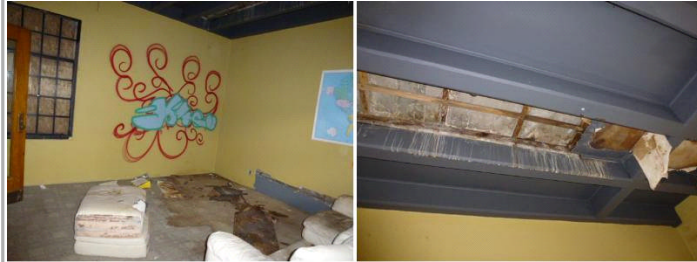
← **Photo #37**

There is moisture damage at the ceiling located in the center north room on the third level.

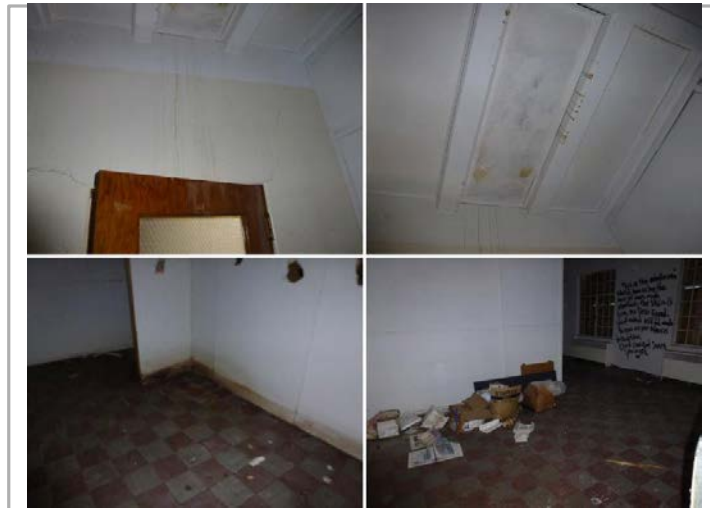
← **Photo #39**

Ceiling damage at the N.W. third floor corner room.

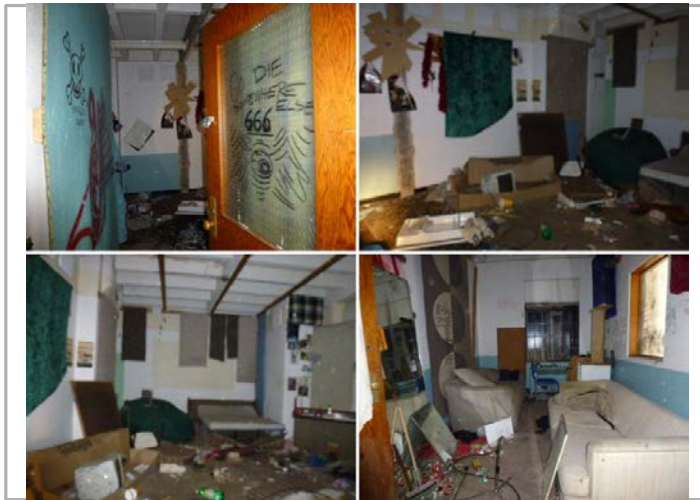
← **Photo #40**

There is evidence of someone living at the S.E. third floor room at some time. Nobody was there at the time of the Assessment.

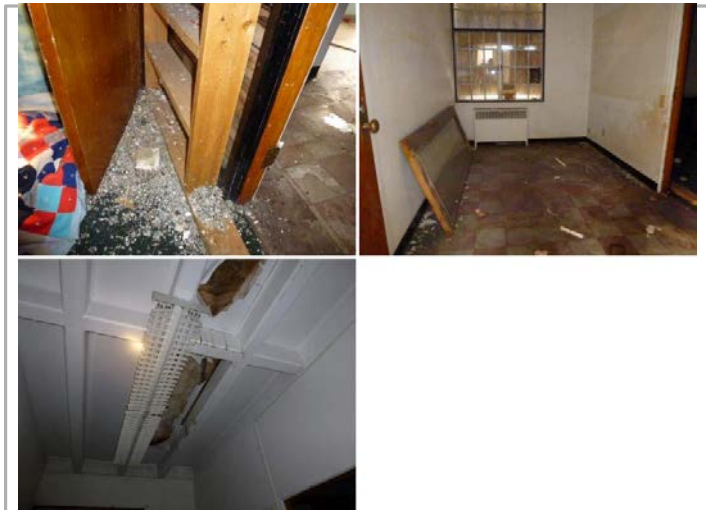
← **Photo #45**

There is water damage to the floors and ceilings located at the second north office east hallway. There is a large amount of bird feces on the walls and floors in this area.
